HISTORIC BLUFF RETREAT AND STABILIZATION AT FLAG HARBOR, CHESAPEAKE BAY, MARYLAND

Inga Clark, Curtis E. Larsen, Michele McRae, U.S. Geological Survey, Reston, VA

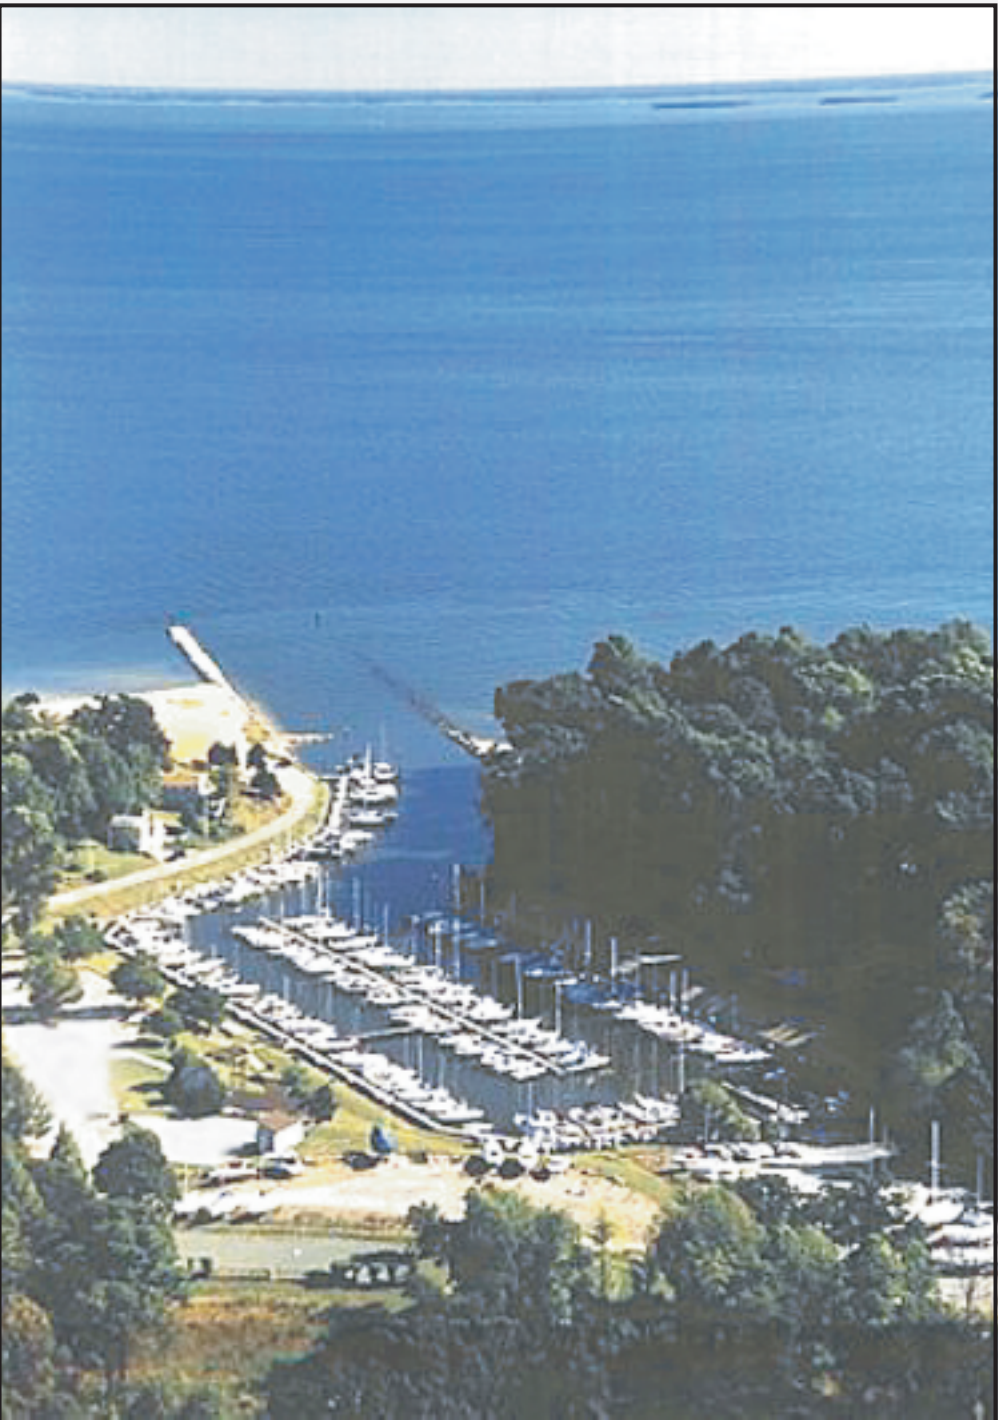
View of the marina at Flag Harbor. Updrift deposition behind the northern jetty (on the left) created beach that protects cliffs nearest to the marina from wave erosion.

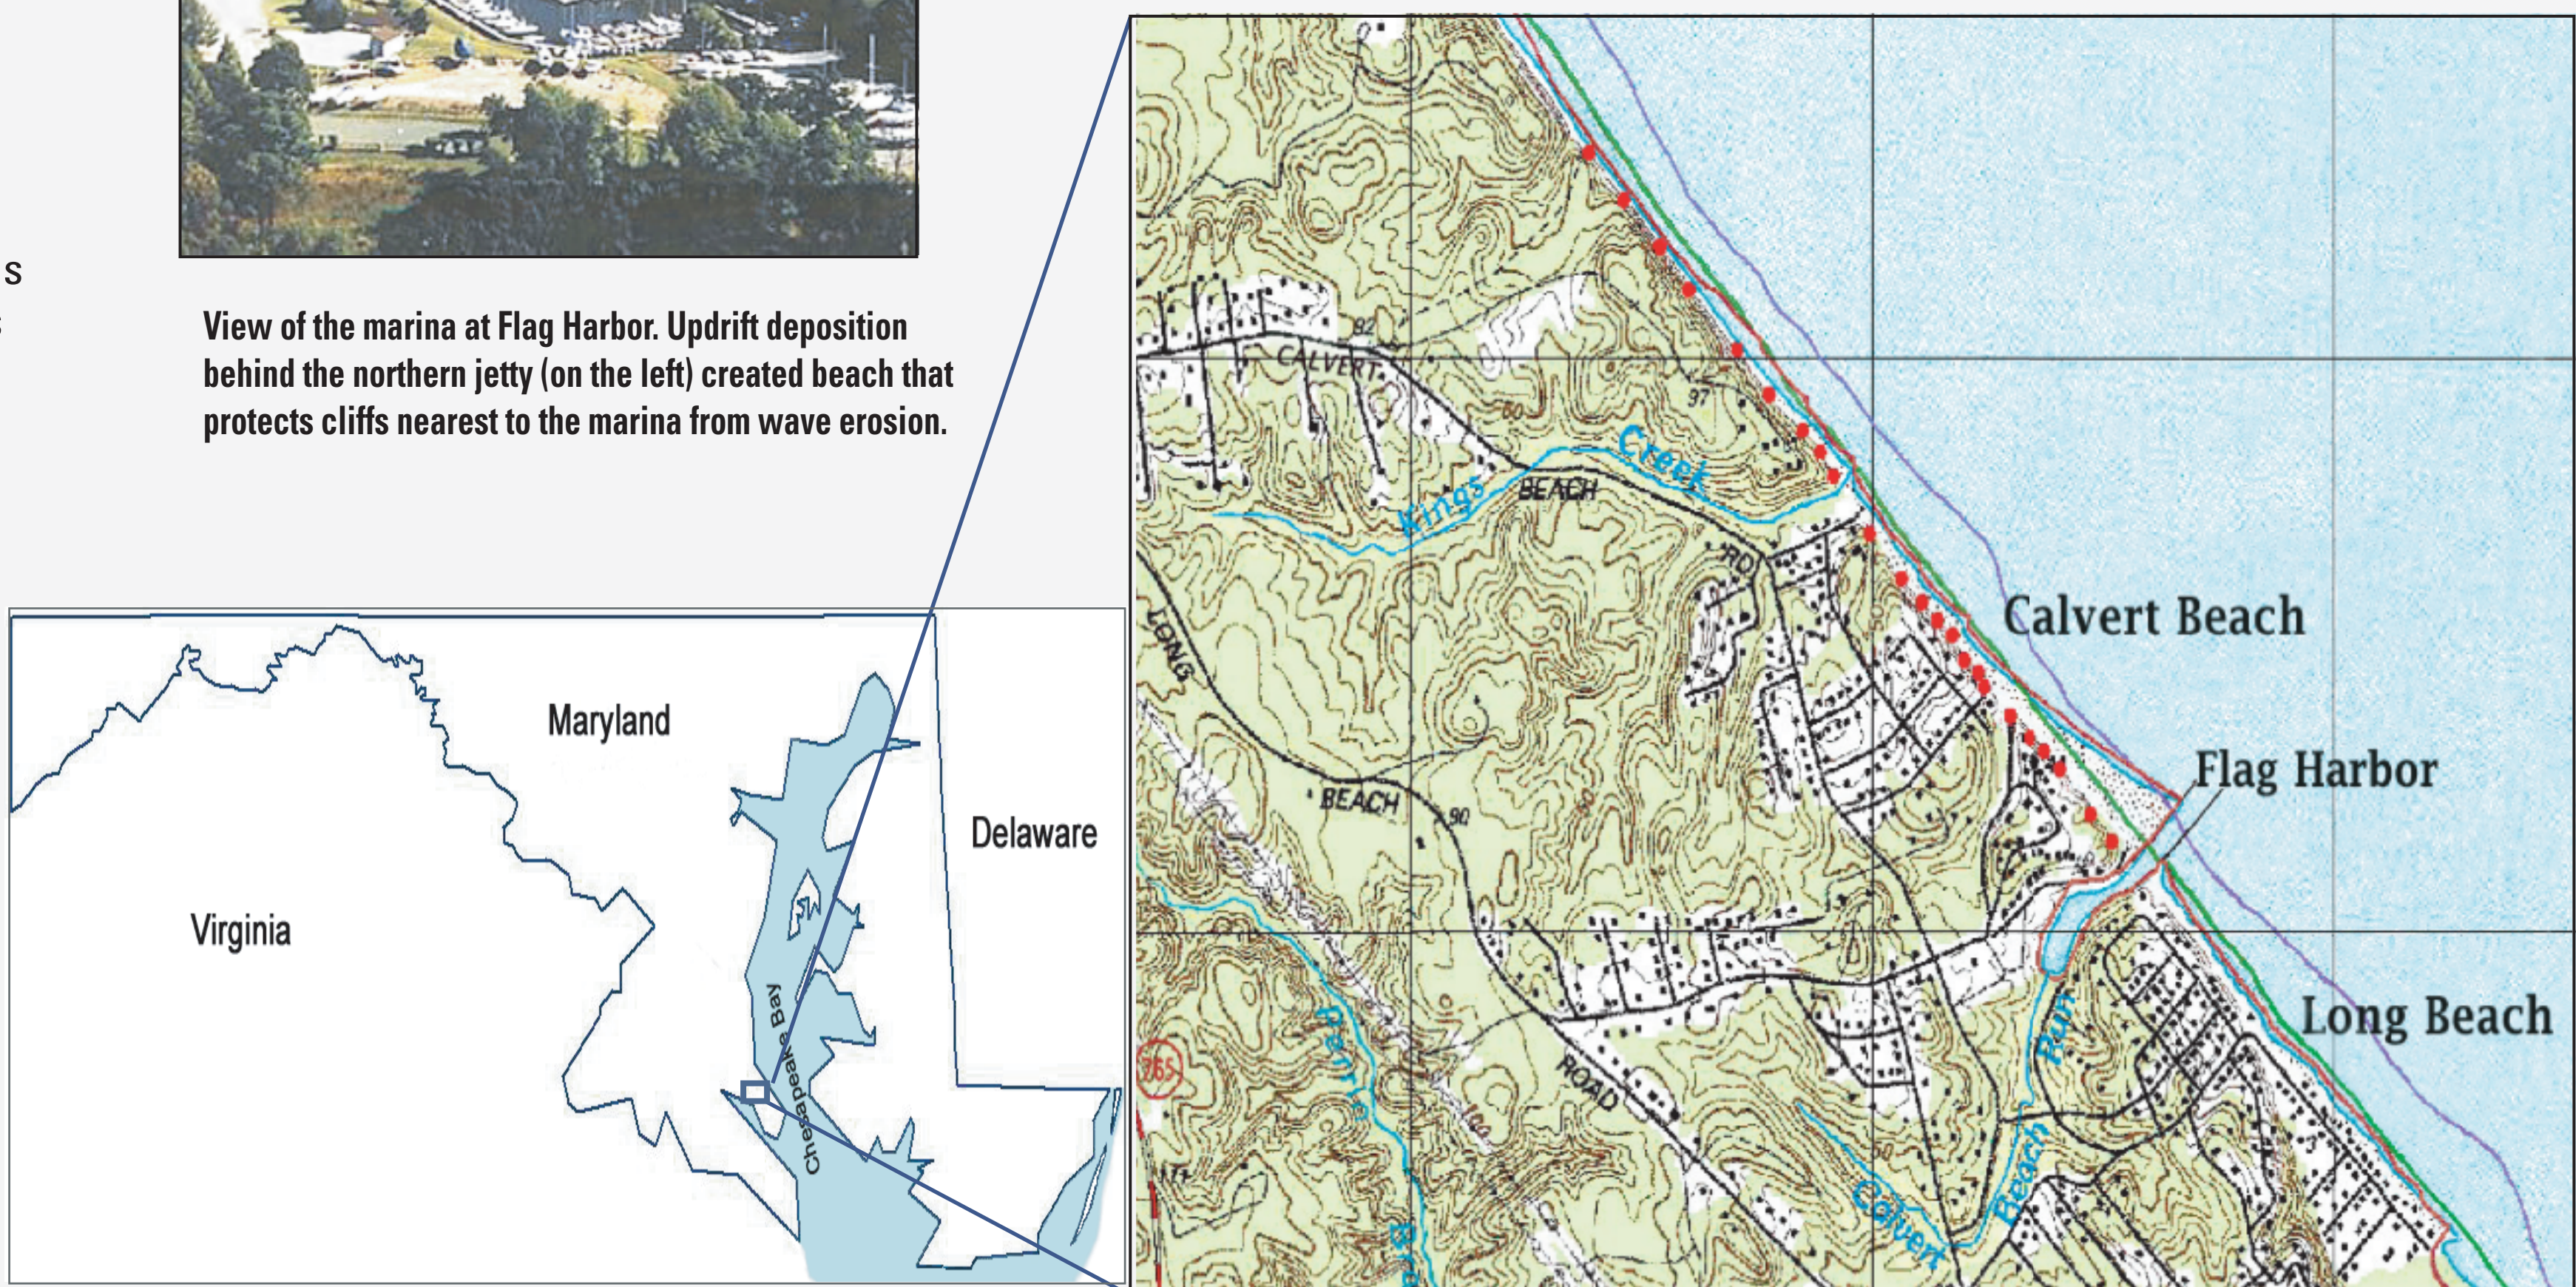
Fig.1 Location of profile stations and historical migration of the Chesapeake Beach shoreline (courtesy of the Maryland Geological Survey): blue line - 1848; green line - 1942; red line - 1993. Topography - 1981. Construction of two jetties at Flag Harbor in 1947 altered the natural pattern of erosion. Parallel retreat of shoreline in this area subsided and finally changed to the deposition of beach sediments.

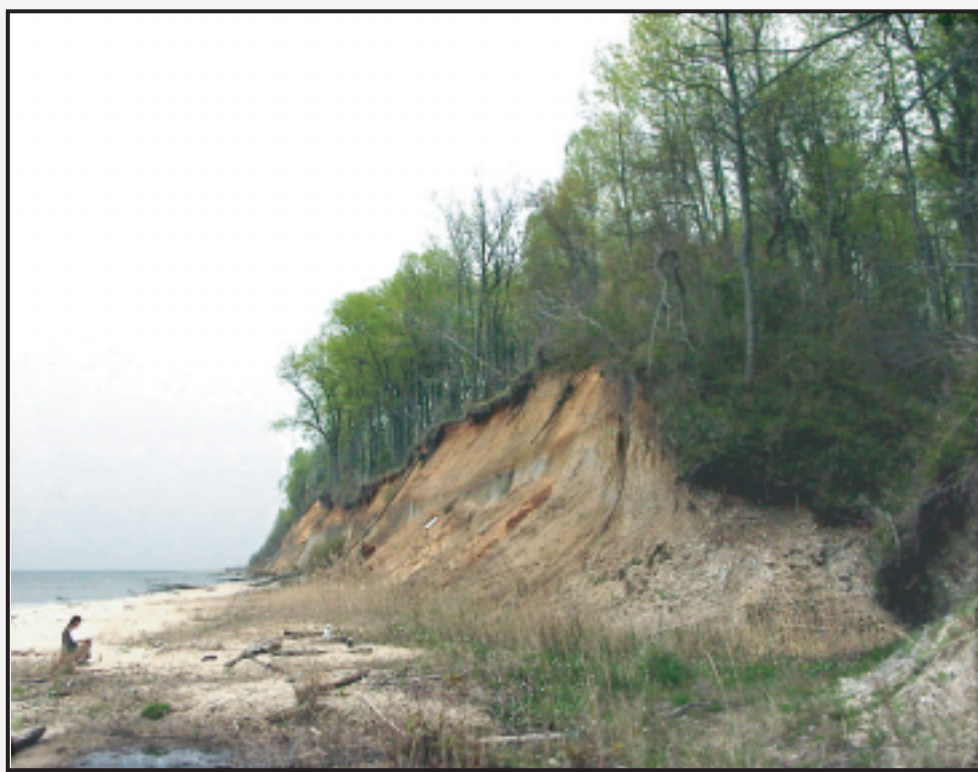
At actively eroding bluffs, wave action erodes intact material at the toe of a bluff. Failure of the slope face and top retreat take place in the form of translational slides and free degradation. Degradation material at the toe of the bluff is removed by waves (pic. 1 - 4)

pic 1 Eroding cliffs to the north of the study area

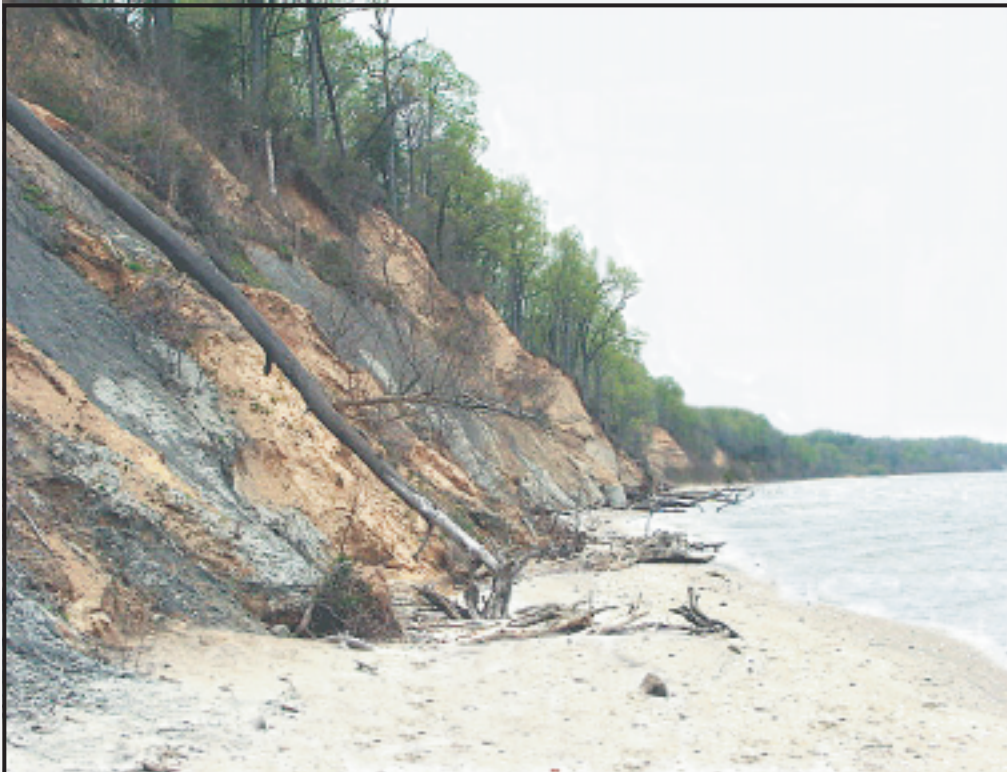
pic 2 General view of Calvert Cliffs north of Kings Creek.

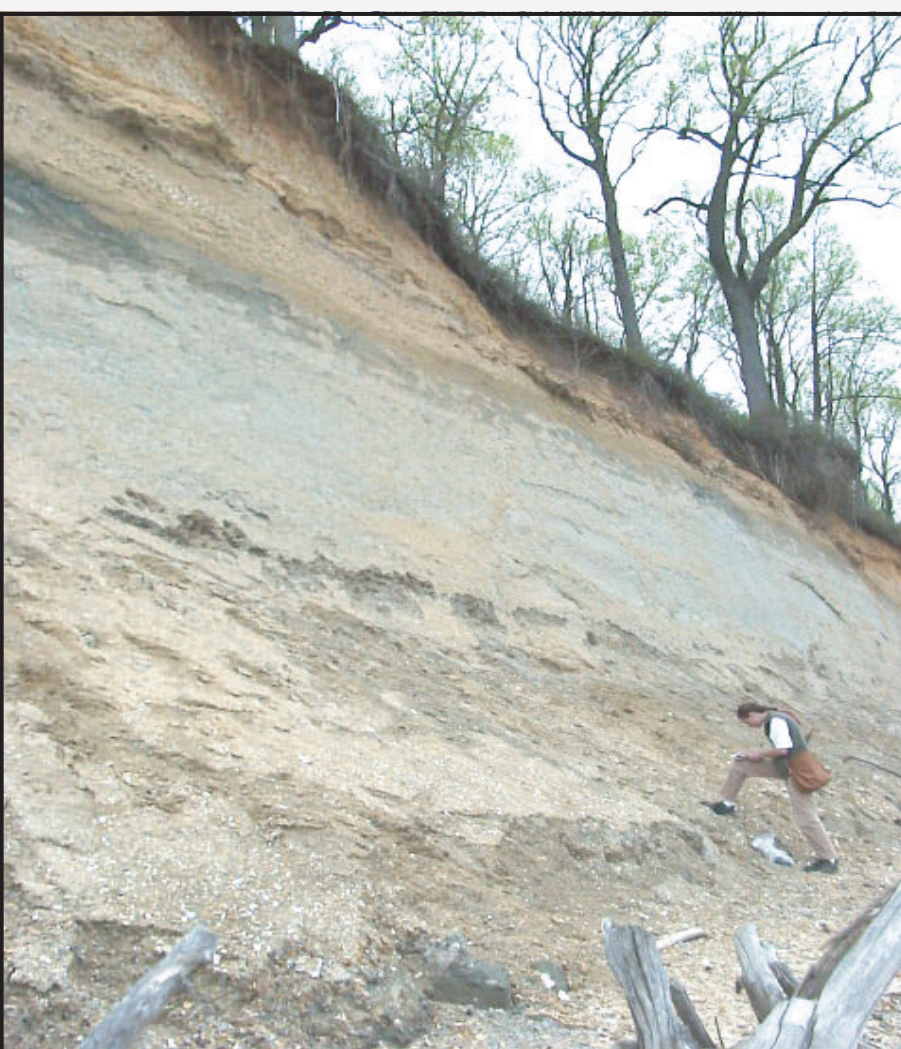
pic 3 Actively eroding cliff. Colluvial material slides to the toe of the bluff and is removed by waves at high tide.

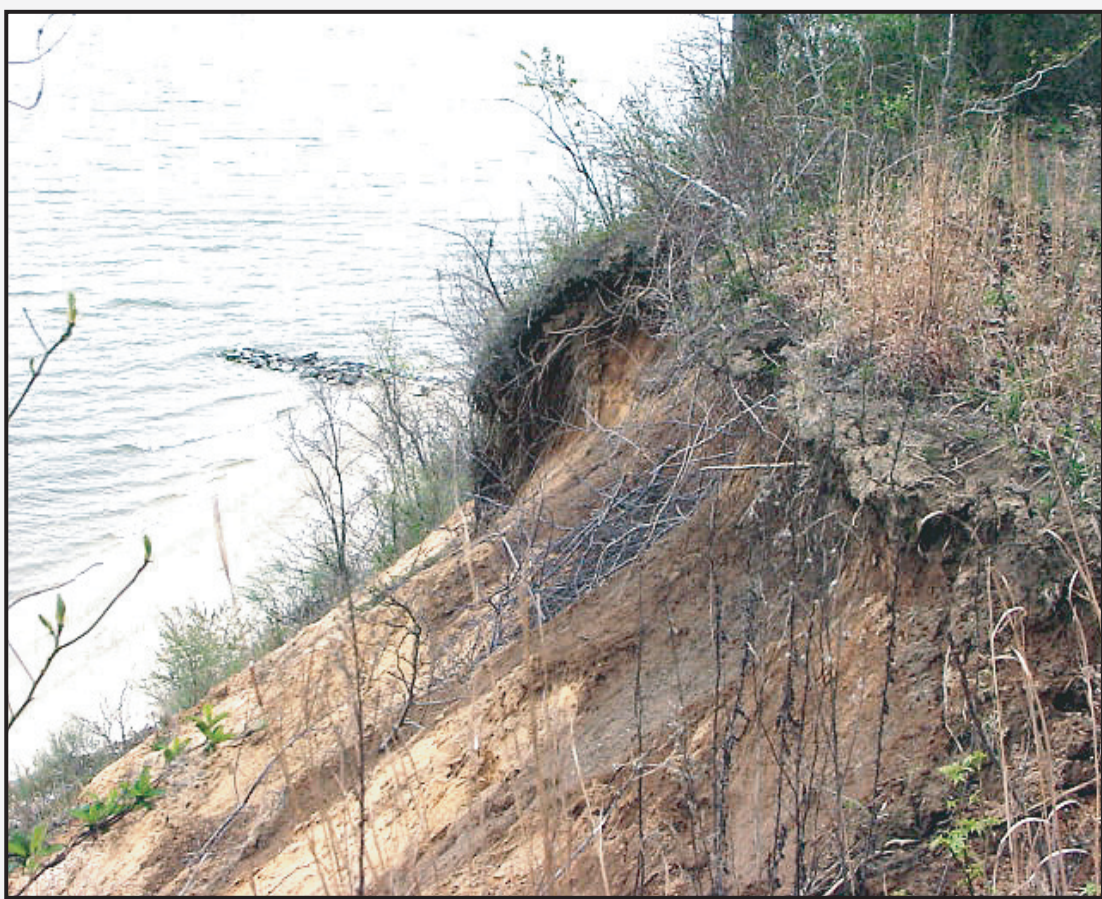
pic 4 Actively eroding cliff. Rotational slides at the top of the bluff created by oversteepened slope

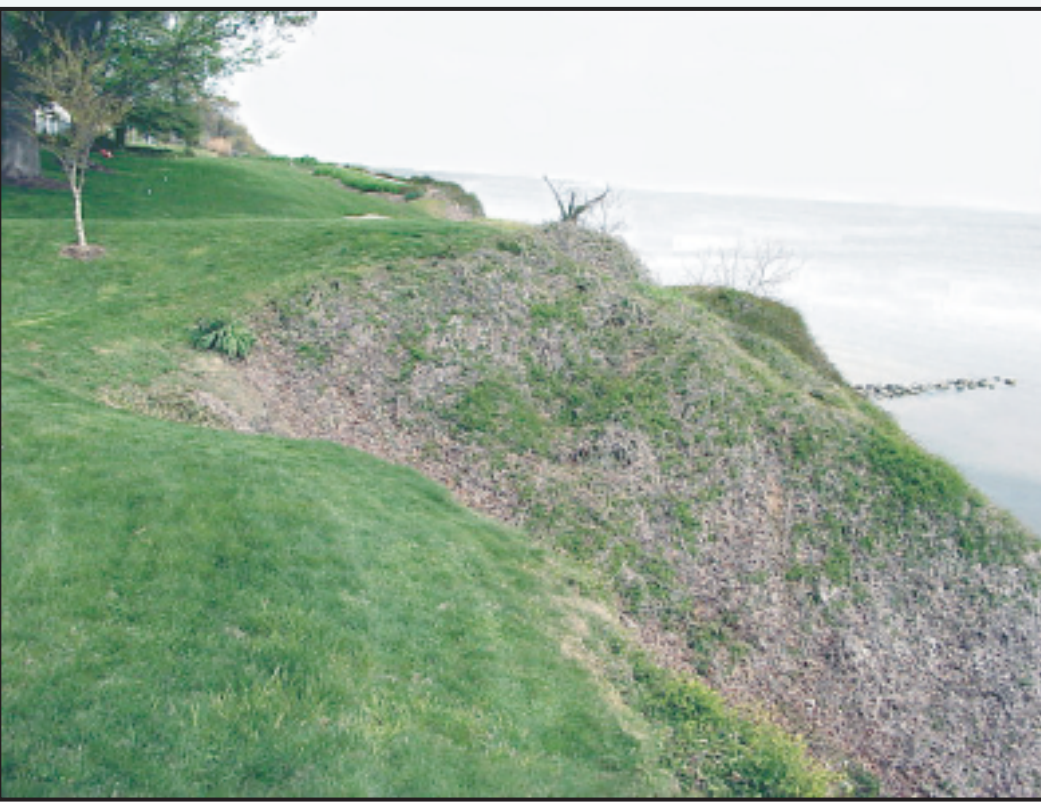
Bluffs protected by a beach progressively attain a uniform stable slope. Rotational slides or slumps propagate from the top of the bluff (pic 5 - 7). Colluvial material is accumulated at the base of the bluff and forms an 'accumulation zone'. Ultimately the slope profile reaches the stable angle equal to the effective angle of shearing resistance of the soil (pic 8).

pic 5 Bluff protected by the beach. Vegetated scarp of an old landslide can be seen on the foreground.

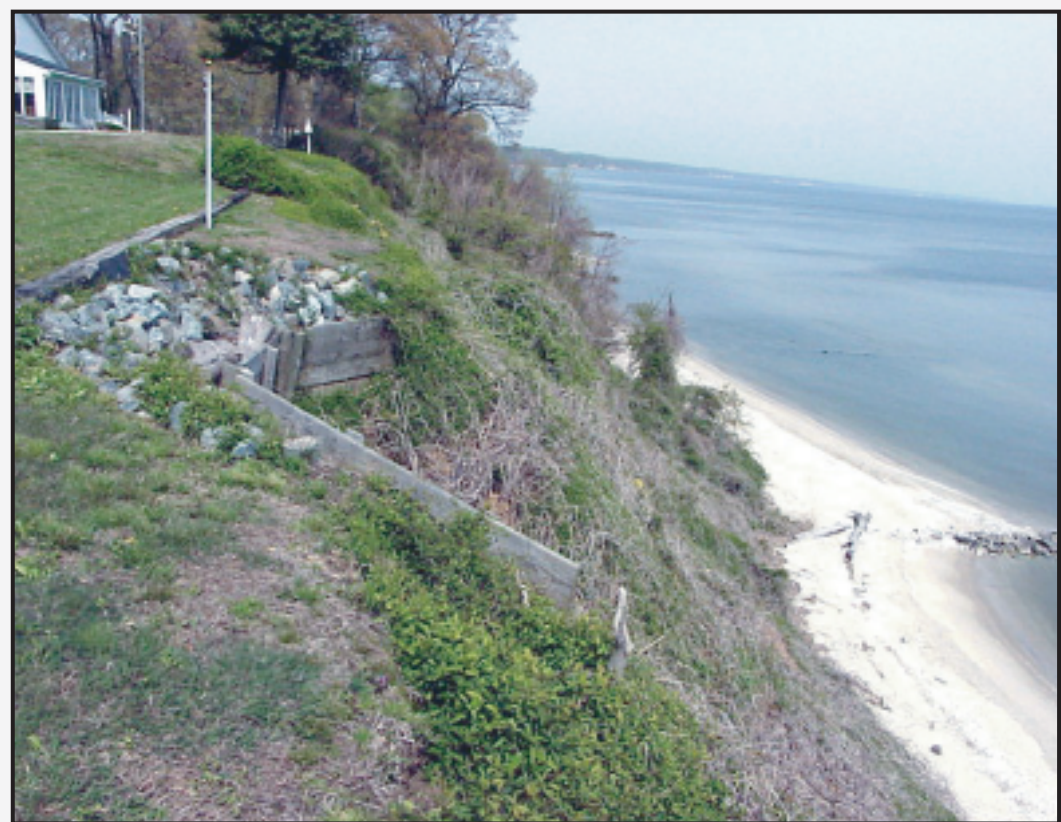
pic 6 Slope in the process of stabilization. Pile of rocks at the edge of the cliff designed to enhance drainage and wood wall prevents soil slumping

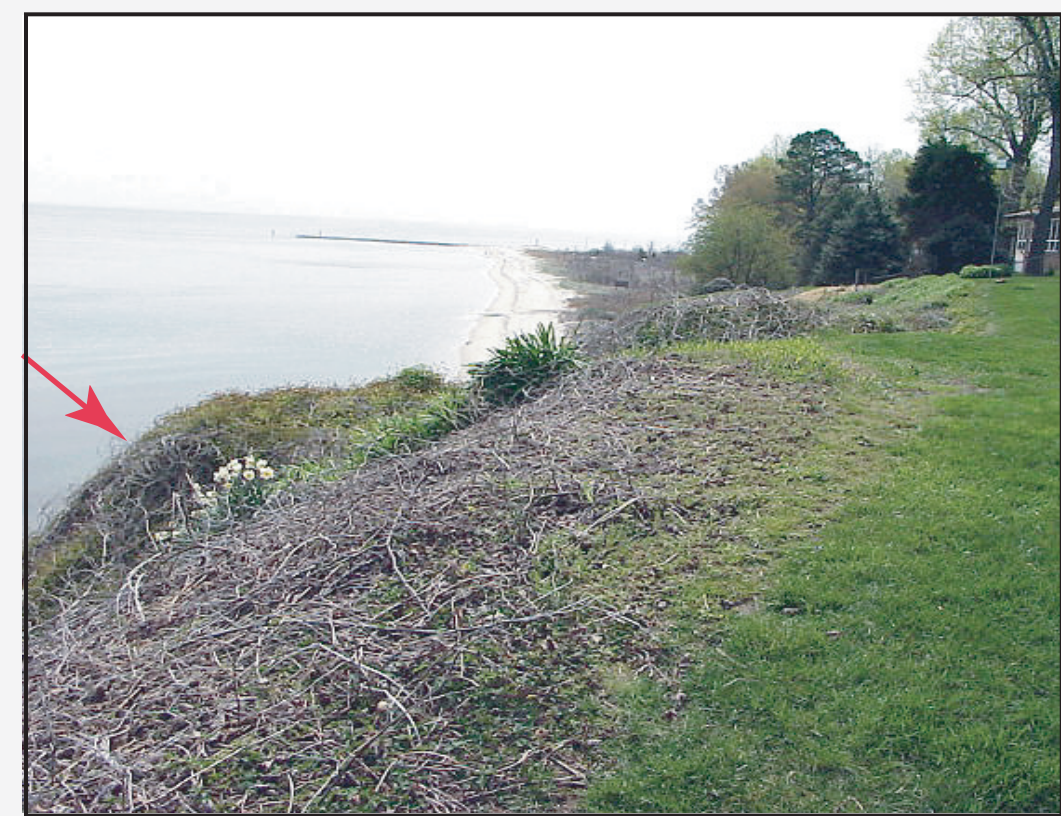
pic 7 Bluff protected by the beach. Mass of sliding material can be seen on the left. Slopes flatten towards the jetty at the marina seen on the background.

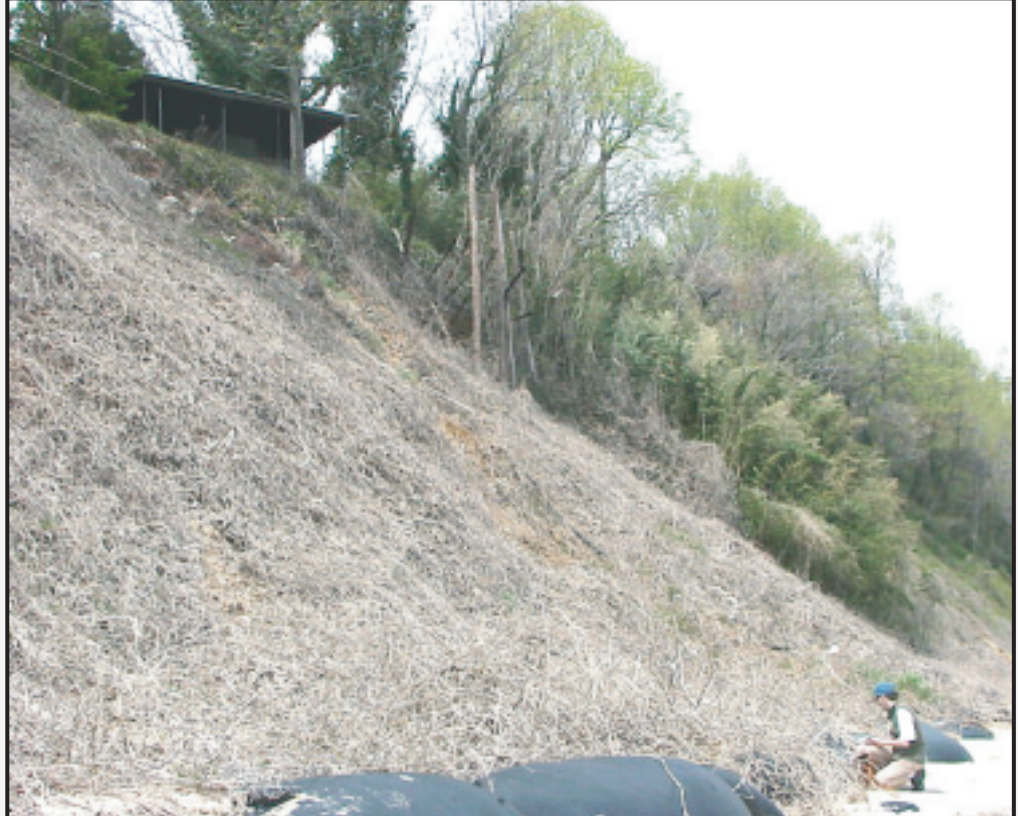
pic 8 Bluff protected by the beach. Bags filled with sand were placed to protect the toe of the slope from wave action. Logs at the center of the picture are the remnants of an old structure designed to prevent soil from sliding.
